CALIFORNIA DEPARTMENT OF CONSERVATION
DIVISION OF MINES AND GEOLOGY

**FAULT EVALUATION REPORT FER-234
SURFACE FAULT RUPTURE ALONG THE JOHNSON VALLEY,
HOMESTEAD VALLEY, AND RELATED FAULTS
ASSOCIATED WITH THE
M_s 7.5 28 JUNE 1992 LANDERS EARTHQUAKE**

by
William A. Bryant
Associate Geologist
November 17, 1992

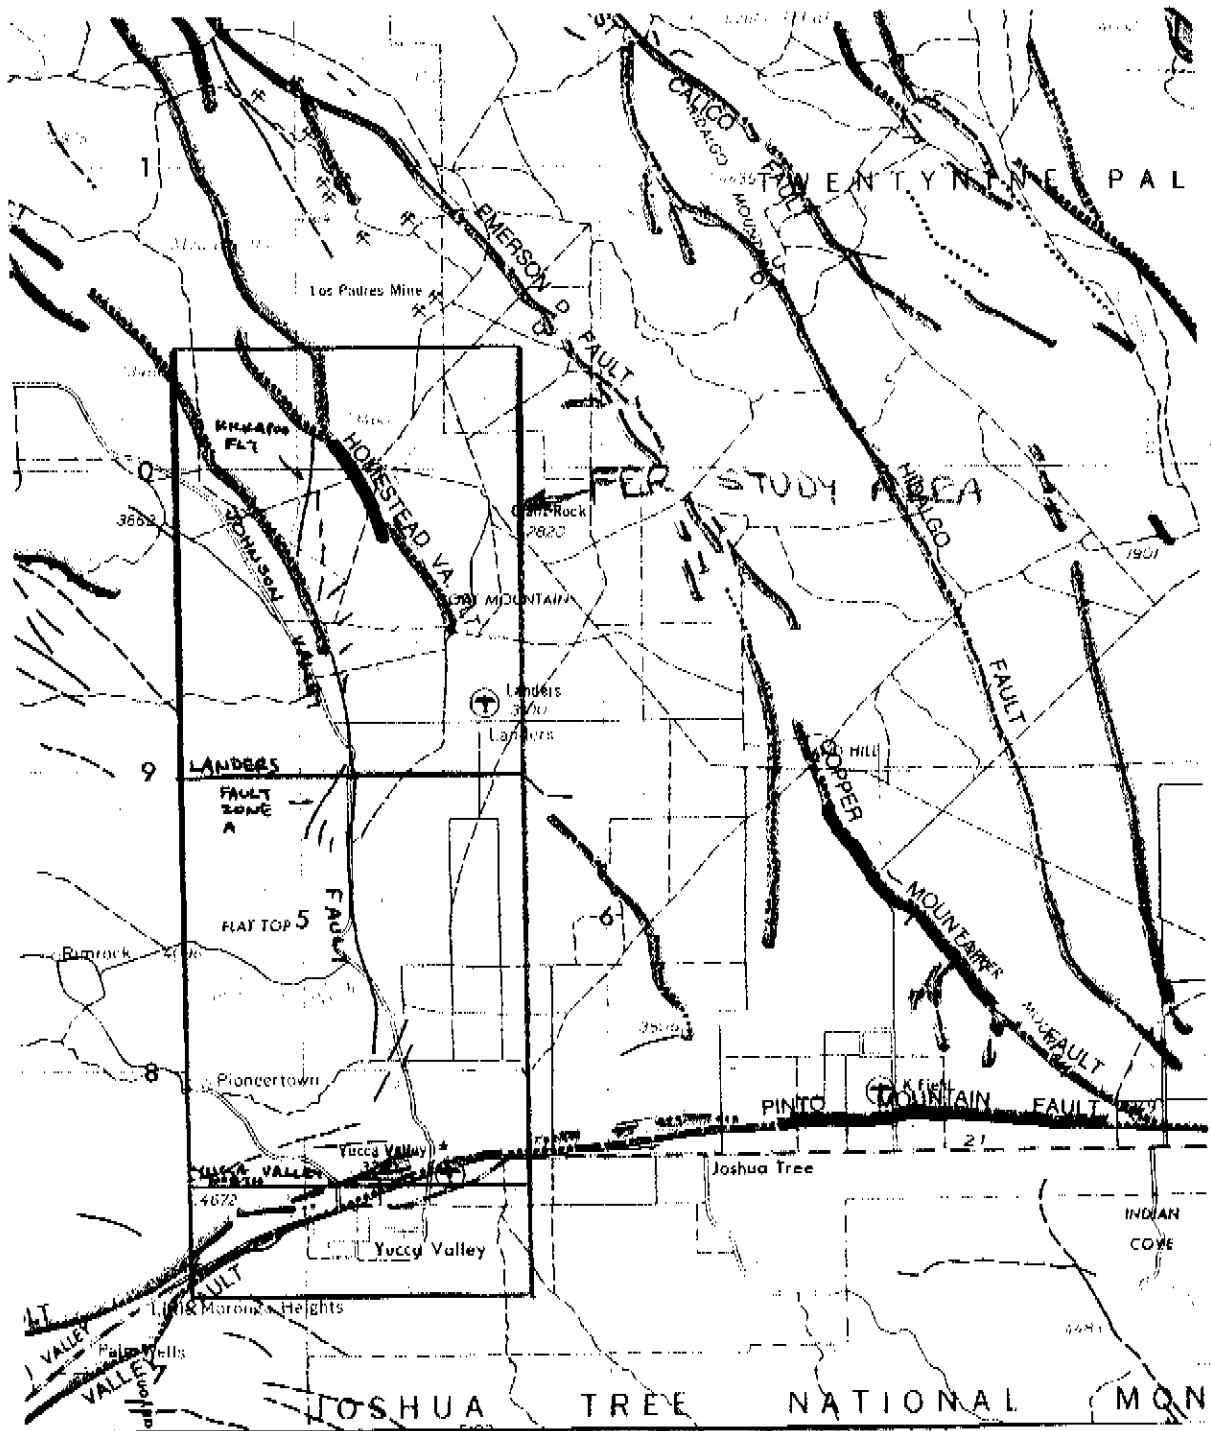
Figure 1 (to FER-234). Location of faults in the Landers-Yucca Valley study area. Fault rupture associated with the 28 June 1992 Landers earthquake are highlighted in red. Base map from Bortugno and Spittler (1986), scale 1:250,000.

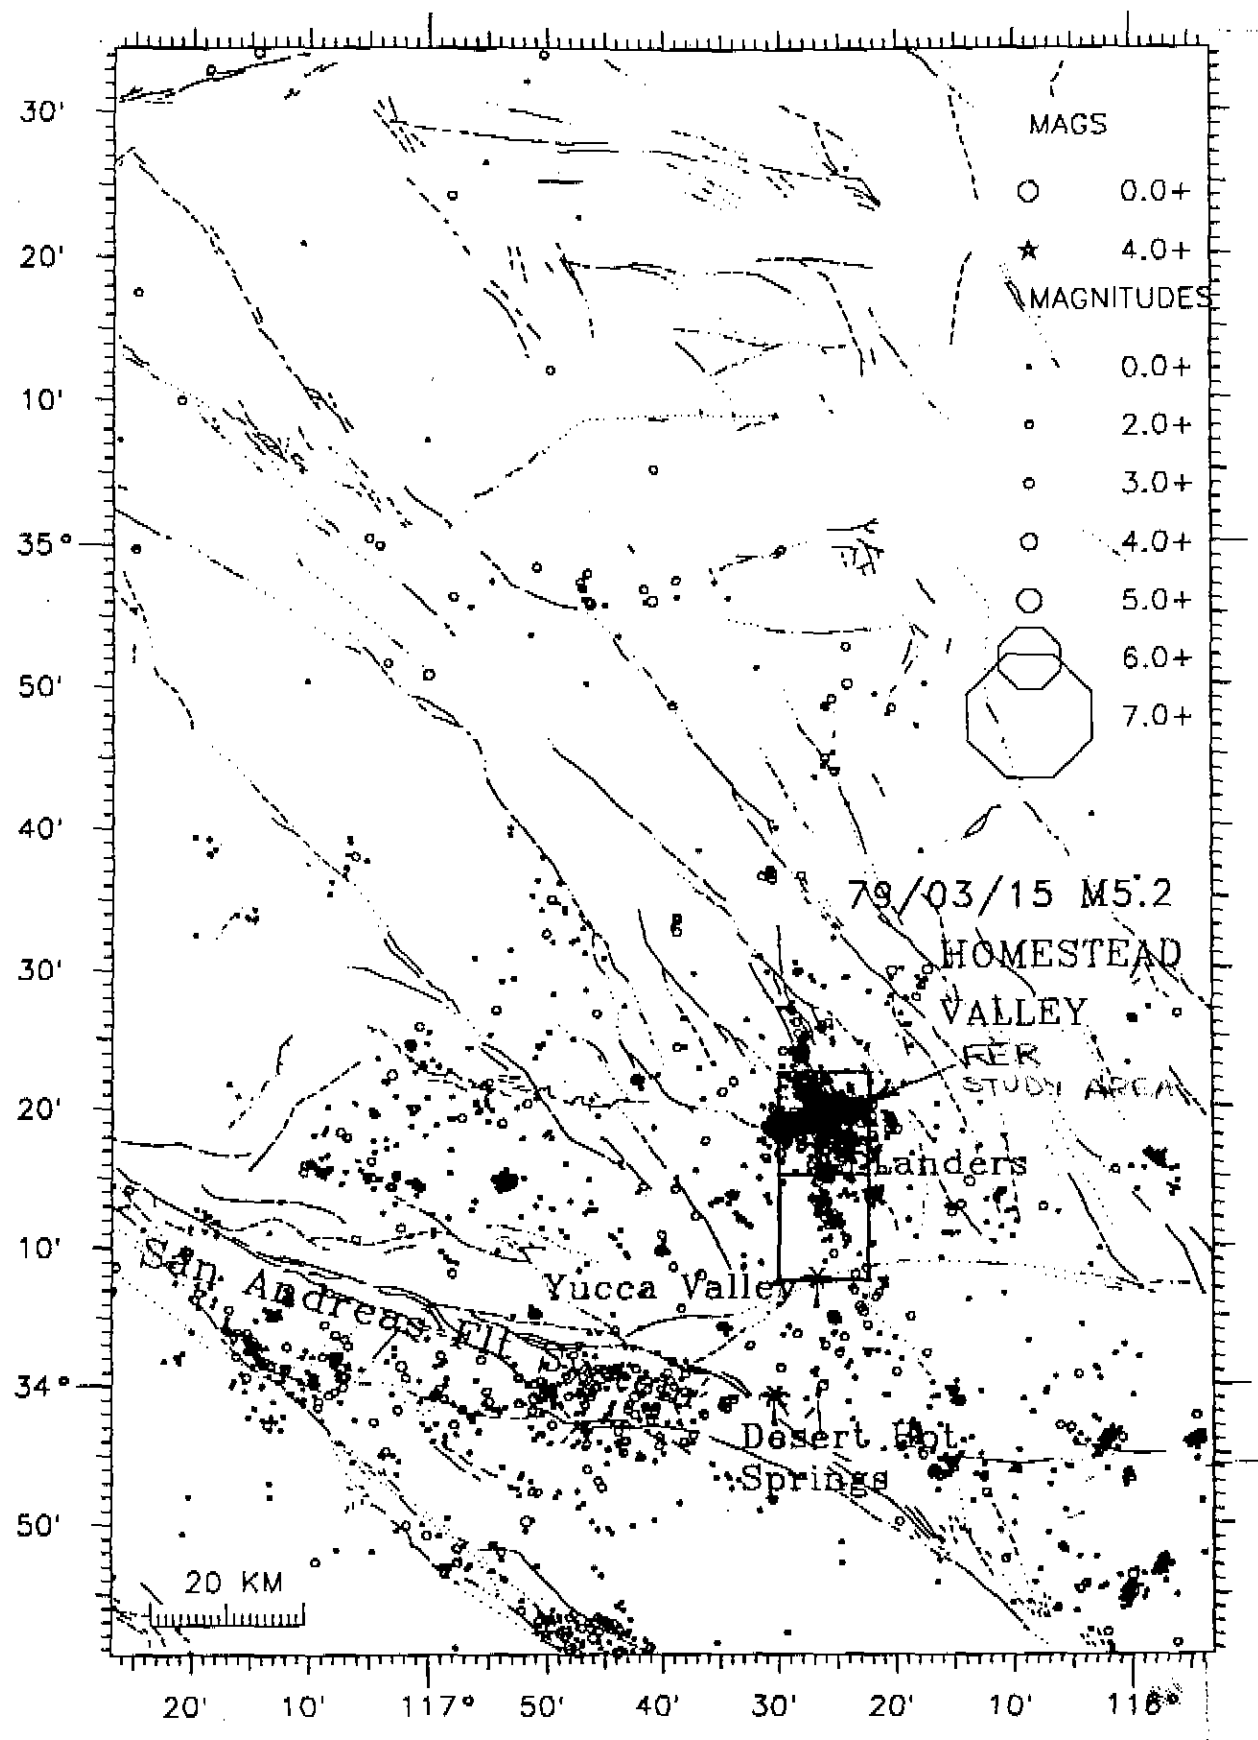
Seismicity in the Landers study area for the period 1932 to 1985 is dominated by the 1979 Homestead Valley earthquake swarm (Figure 4). Hutton and others (1980) stated that only one event of magnitude 2.5 to 3.0 occurred in Homestead Valley during the period between 1 January 1970 and 14 March 1979. More than 3,000 events occurred in this region between 15 March and 30 June 1979.

Figure 4 (to FER-234). Seismicity in the Landers-Yucca Valley study area for the period 1979 to 1980, based on locations from Hauksson and others, 1992.

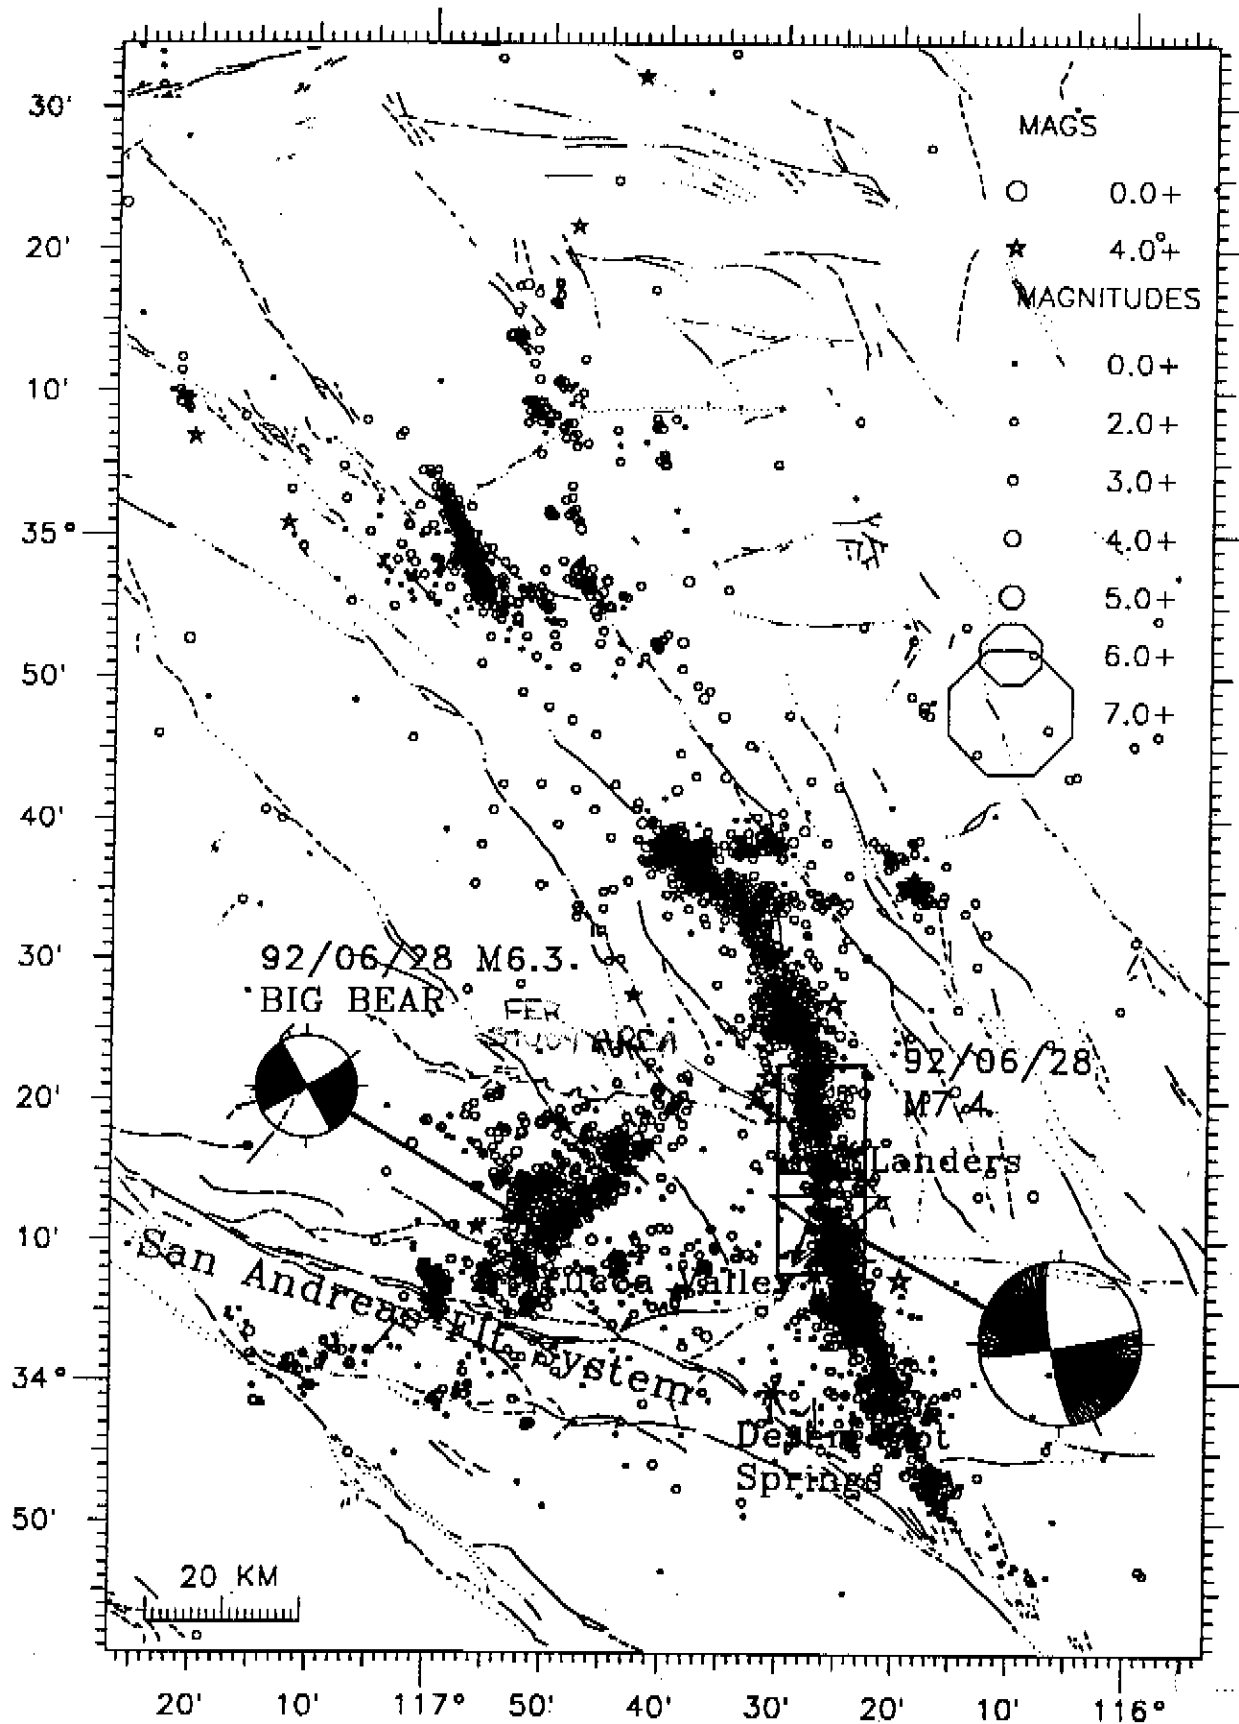
Earthquake epicenters in the FER study area for the period April to July 1992 are shown in Figure 5 (Hauksson and others, 1992). The Joshua Tree earthquake sequence of April 1992 is located south of the Pinto Mountain fault.

Figure 5 (to FER-234). Seismicity in the Landers-Yucca Valley study area for the period June 28 to August 18, 1992. Map from Hauksson and others, 1992.
